# TerraLogos Home Energy Report<sup>®</sup>

Joe Strummer  
16 Glen Acres Way  
Riverside, Maryland 21867

August 4, 2008

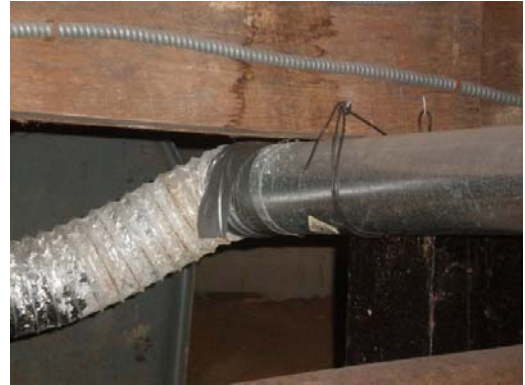
- During the Blower Door Infiltration Test, air was observed flowing from both the return and supply registers. This indicates that there are leaks in the ducts feeding these registers, allowing exterior temperature air into the system and leaking conditioned air to the outside.

- There are visible leaks in hard ducts.
- There are leaks at most of the air registers at the joint between the duct and the surrounding wall or floor finish.

- Where duct leaks are accessible and visible, seal them using conventional duct sealing methods with mastic and foil tapes (not duct tape.)
- Where duct leaks are concealed, seal them with a systemic leak repair procedure, such as the AeroSeal® system by Carrier (See their web site at [www.aeroseal.com](http://www.aeroseal.com).)
- Seal the gap behind the air registers at the joint between the duct and the surrounding wall or floor finish.

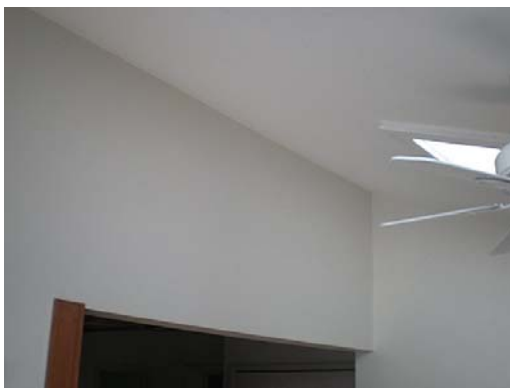
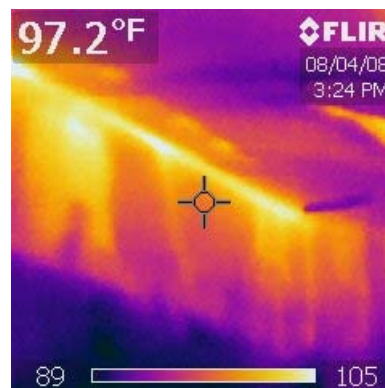
- The unsealed top plates of the interior partition walls are a significant source of air leakage (below photo and IR image). These partition top plates are accessible at the attic floor underneath the existing insulation.
